# San Miguel Home Inspections

## Inspection Report For:

John Doe's House, Calle XXX, Independencia

## 1.0 Roof/Decks/Terraces

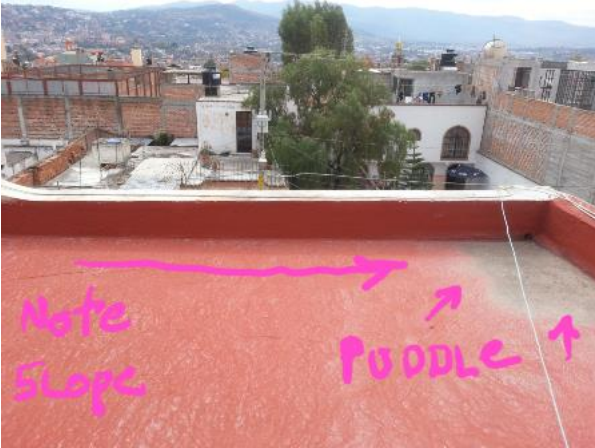
The slopes appear adequate and the canales and drains appear to function. A water test was not performed but you can see that water collects a little in front of the down drain corners. No leaking below these puddle areas was noted.

Note height of parapet from left to right increases, showing slope of roof.  
Note dusty puddle area in front of down drain,

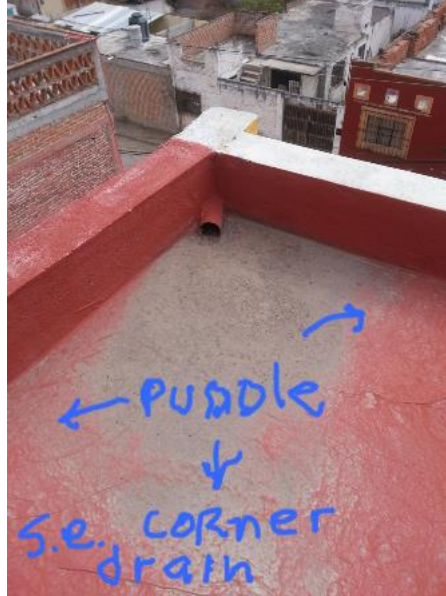
Dust from puddles when it rains in front of down drain.

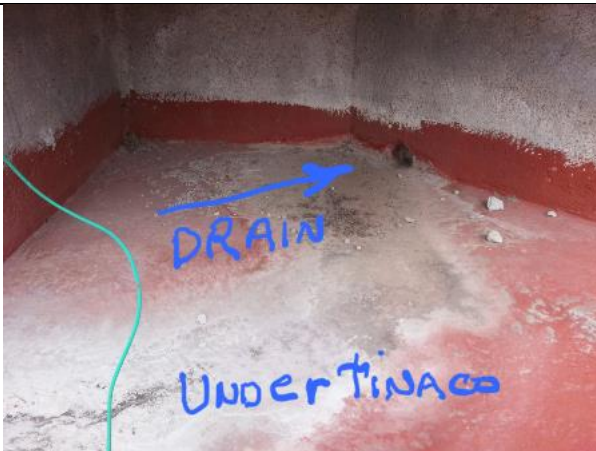
Down drain in corner is pvc, runs inside wall to rear courtyard. Cement dust under tinaco.

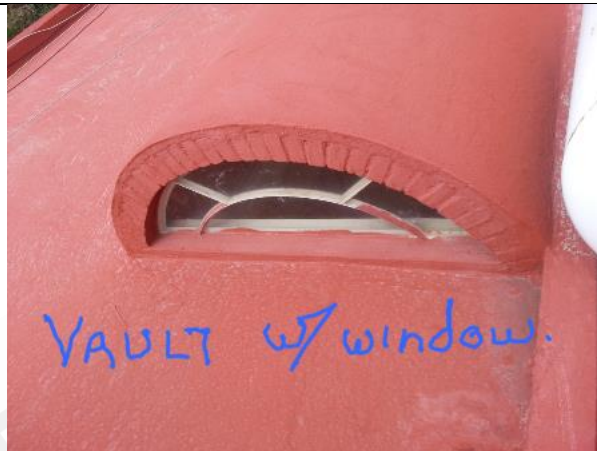
Long vault on upper roof, window at each end, all in good condition, well sealed.

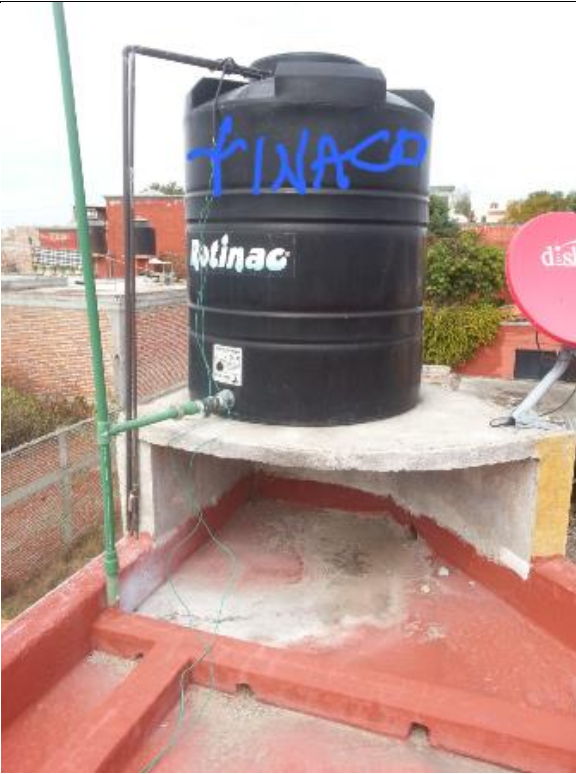
A little messy under tinaco platform from some previous construction. Dish for satellite TV not connected.

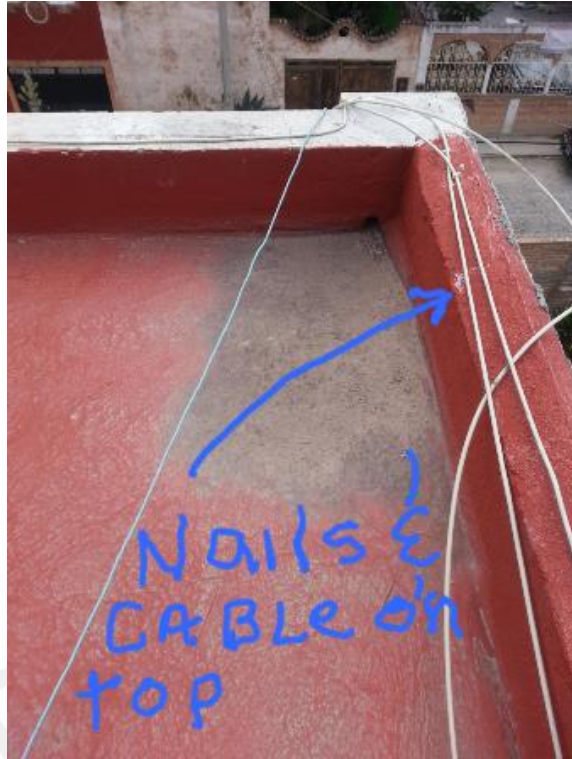
White cable is TV cables and go to rooms below. Note puddle in front of drain typical.

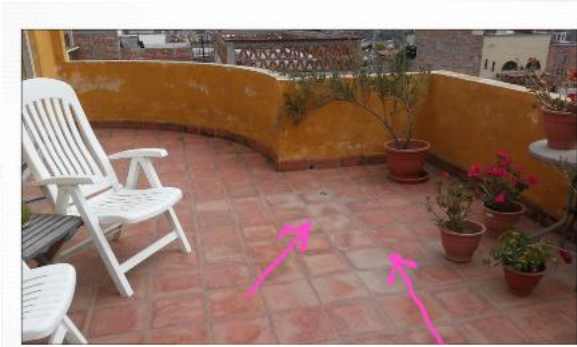
2nd level terrace drains, roof is tile over concrete.

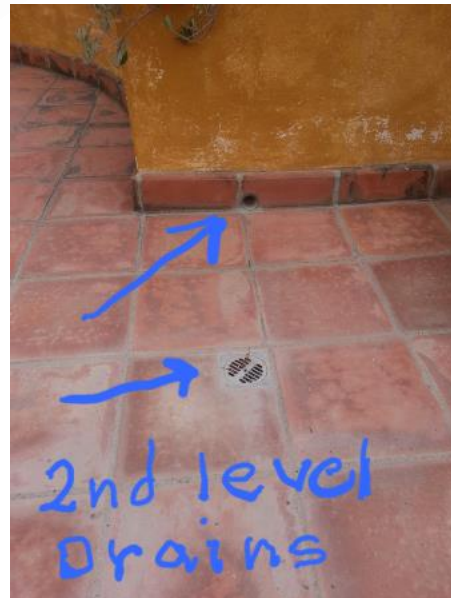
Down drain and overflow drain on 2nd level terrace roof.

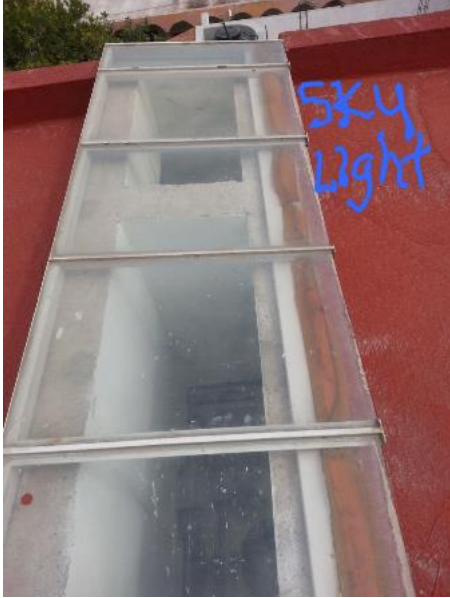
Skylight is nicely tilted and left open on the low side for air circulation. This allows heat to escape in the winter but is not a bad idea in the summer. Someone has installed upholstery foam to block cold air from entering the bathroom. The condensate is damaging the paint surface on the inside of the skylight box. An easy fix is to put an absorbent material (e.g. tampons) on the ledge where it cannot be seen to absorb and then evaporate the moisture without dripping. This is one way to manage the "humidity cycle" of a bathroom when no fan is available.

Right side sealed with upholstery foam

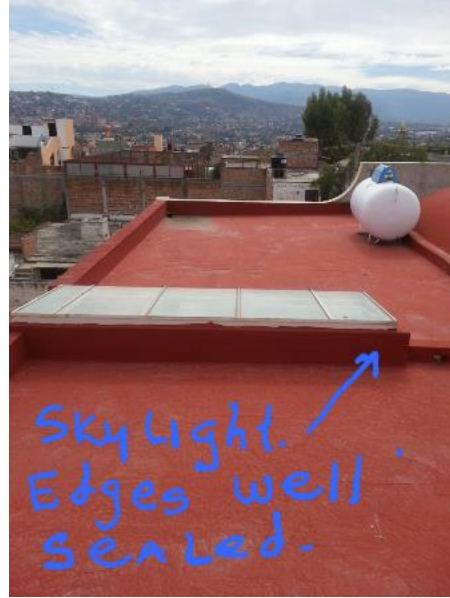
Perimeter of tilted skylight well sealed,

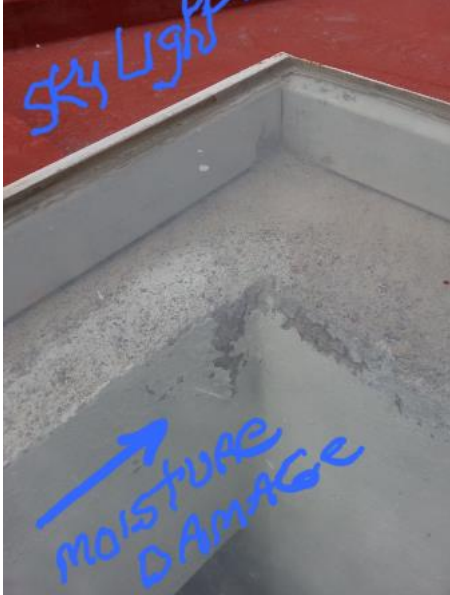
Condensate in bath below  
collects on glass & drips
